# QUANTIFICATION OF CHANGES IN SURFACE CONDITIONS OF AIRPORT PAVEMENTS IN JAPAN

Yoshitaka HACHIYA, Takashi WATANABE, Kentaro KITAOCHI and Takehiko KODA  
Service Center of Port Engineering (SCOPE), JAPAN

**ABSTRACT:** An airport pavement management system (APMS) has been under development in Japan. In particular, a surface condition evaluation subsystem based on the method of a Pavement Rehabilitation Index (PRI) has been in use for two decades or more. This PRI method was completed in the early 1980s as a means of evaluating the surface condition of airport pavements by calculation based on objective measurements of surface conditions, as derived from the subjective opinions of pavement engineers. By comparing the calculated PRI value against appropriate criteria, the need for pavement rehabilitation work can be judged for runway, taxiway, and apron pavements. Japan's APMS is described in outline, along with the closely related rehabilitation subsystem. The evaluation of surface conditions using the subsystem is described in detail and use of the results to judge the need for rehabilitation work is explained. In the analysis, the present conditions of airport pavements are summa

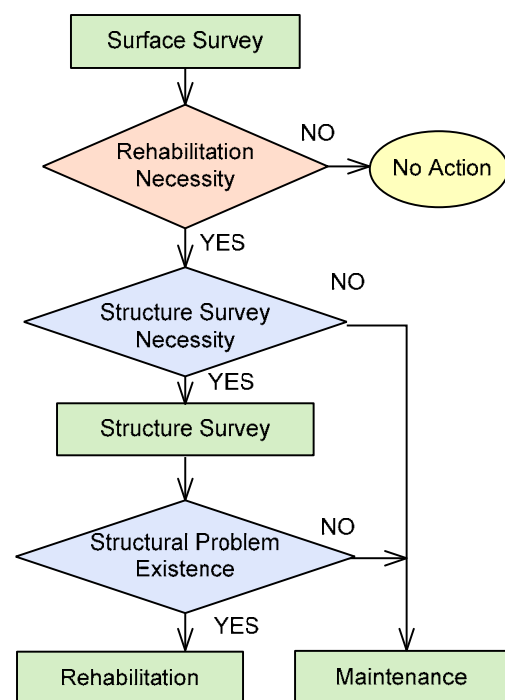
**Figure 1** shows a flow chart of the evaluation and rehabilitation subsystems, in which fundamental evaluation, and maintenance and rehabilitation process consists of the following steps.

**Figure 1** Flow chart of evaluation and rehabilitation subsystems for airport pavement management

### 1) Surface condition evaluation

The condition of the airport pavement surface is surveyed every three years. When the physical condition of the surface is judged to have seriously deteriorated, certain rehabilitation work may become necessary. In order to determine a suitable time for carrying out this rehabilitation work, an objective method using the already-mentioned PRI has to be applied.

### 2) Structural condition evaluation

If the above-mentioned PRI method indicates that certain rehabilitation work is necessary, the structural condition of the pavement has to be checked. Non-destructive testing procedures using a Falling Weight Deflectometer (FWD) are adopted for airport pavements.

### 3) Rehabilitation method selection

If the structural condition of a pavement is found to be unsound, rehabilitation work is necessary. However, some maintenance work may be needed even if the pavement is sound structurally.

### 4) Rehabilitation work design

Based on the decision made above, the procedure for the rehabilitation work should be determined. In general, there are two methods of rehabilitation, overlay and reconstruction.

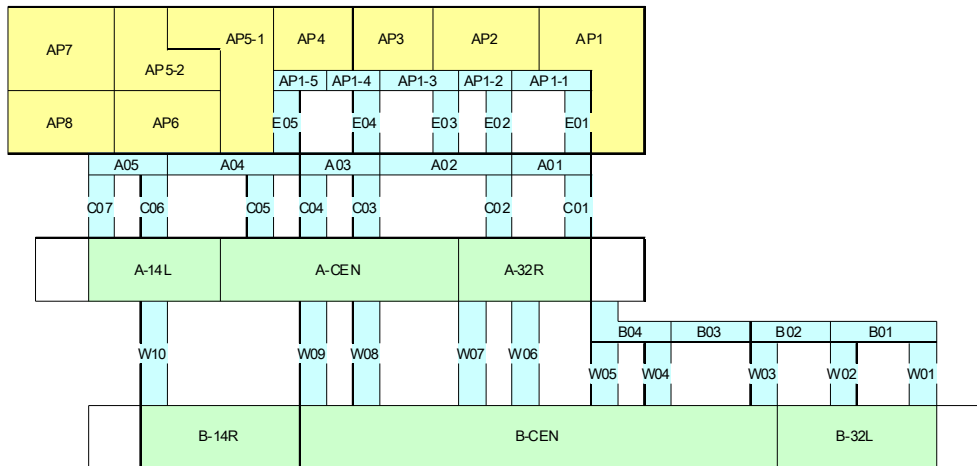
The surface conditions of runways, taxiways and aprons were evaluated in 163, 273, 101 units, respectively. When the annual changes in PRI and the recovery of PRI due to rehabilitation works are analyzed in each unit, the results vary largely. Thus, the units are summed into several groups as shown in **Figure 5**. The runways A and B were separated into three blocks (two end parts and one intermediate part) in each, and the aprons were divided into nine blocks in consideration of the aircraft running lines. The taxiways were divided into perpendicular taxiways, high-speed exit taxiways and parallel taxiways.

**Figure 5** Groups for PRI calculation at Osaka Itami Airport
