# QUANTIFICATION OF CHANGES IN SURFACE CONDITIONS OF AIRPORT PAVEMENTS IN JAPAN

Yoshitaka HACHIYA, Takashi WATANABE, Kentaro KITAOCHI and Takehiko KODA  
Service Center of Port Engineering (SCOPE), JAPAN

**ABSTRACT:** An airport pavement management system (APMS) has been under development in Japan. In particular, a surface condition evaluation subsystem based on the method of a Pavement Rehabilitation Index (PRI) has been in use for two decades or more. This PRI method was completed in the early 1980s as a means of evaluating the surface condition of airport pavements by calculation based on objective measurements of surface conditions, as derived from the subjective opinions of pavement engineers. By comparing the calculated PRI value against appropriate criteria, the need for pavement rehabilitation work can be judged for runway, taxiway, and apron pavements. Japan's APMS is described in outline, along with the closely related rehabilitation subsystem. The evaluation of surface conditions using the subsystem is described in detail and use of the results to judge the need for rehabilitation work is explained. In the analysis, the present conditions of airport pavements are summa

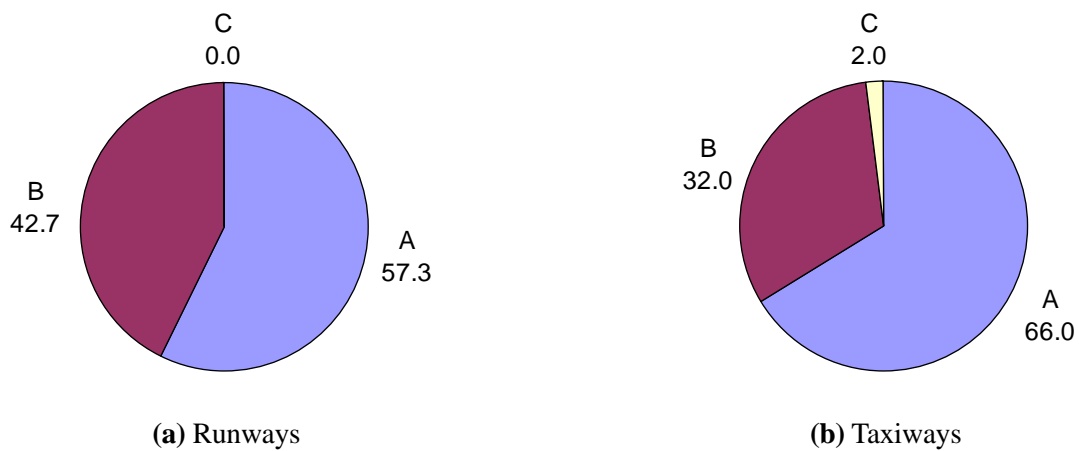
**Figure 3** shows the need for rehabilitation work as judged from these PRI values in accordance with the criteria given in **Table 1**. Looking at runways, the proportion of pavements classified as A is about 60% and the remainder is B. On the other hand, about 70% of taxiway pavements are ranked as A, but there are some ranked as C. Although PRI values are smaller for taxiways than for runways, the difference in need for rehabilitation results from the different criteria used for runways and taxiways.

**Figure 3** Need for Rehabilitation Work
